**RECENT OPTICAL AND SEM CHARACTERIZATION OF GENESIS SOLAR WIND CONCENTRATOR DIAMOND-ON-SILICON COLLECTOR.** J. H. Allton<sup>1</sup>, M. C. Rodriguez<sup>2</sup>, P. J. Burkett<sup>3</sup>, D. K. Ross<sup>3</sup> and C. P. Gonzalez<sup>3</sup> and K. M. McNamara<sup>1</sup>, <sup>1</sup>NASA/Johnson Space Center, 2101 NASA Parkway, Mail Code KT, Houston, TX 77058, USA, [Judith.h.allton@nasa.gov](mailto:Judith.h.allton@nasa.gov), <sup>2</sup>ESGC Geocontrol Systems- ESCG at NASA/JSC, <sup>3</sup>Jacobs- ESCG at NASA /JSC.

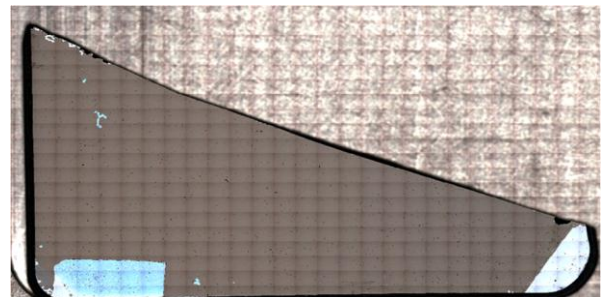
Fig. 2. Fragment 60000 color-enhanced to show increased blueness of silicon areas near focal point, presumably due to irradiation. The bright areas are silicon, called “heel” and “toe” of sock shape.

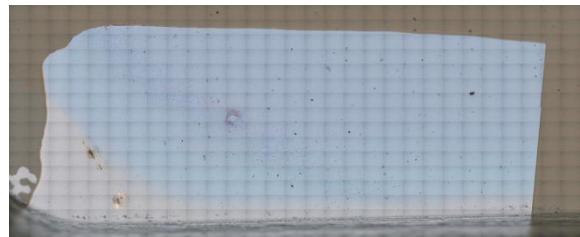
*Typical post-landing particulate contamination.* Optical imaging of 60000 reveals glass microsphere shards and carbon fibers (both return capsule structural materials), dried droplets, miscellaneous fibers, smears and particles. Near the frame attachments, on the silicon “heel” and “toe” surfaces, smears of gold-colored material are noted (Figs. 3 & 4). A brief survey of related fragment, 60737, was undertaken via SEM (JEOL 7600F). Most abundant particles were gold (with nickel and/or aluminum) and GaZnAl-oxide bearing paint. Less abundant particles consisted of silicate glass, germanium metal, stainless steel, and terrestrial soil.

Fig. 3. Silicon “heel” showing frame shadow and gold-colored smears.

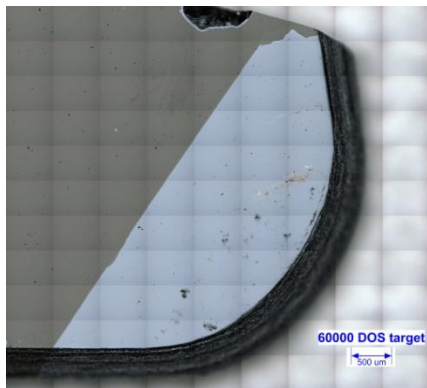
Fig. 4. Silicon "toe" showing gold-colored smear and debris.

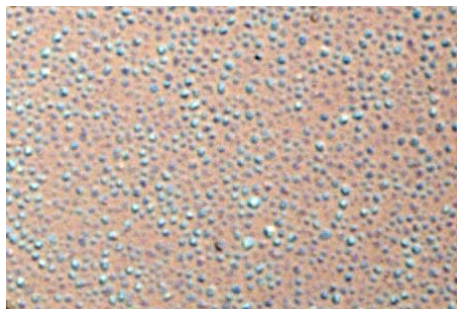
*Evidence of irradiation damage near focal point silicon.* Optical imaging revealed a correlation of “blueness” and presence of bubble texture (Fig. 5). No gradient was noted across “heel”. Bubble texture is not observable on “toe”. Estimated flux gradient is 20X near focal point vs 6X near outer radius (Wiens, personal communication).

Fig. 5. Bubble texture on blue areas of silicon Bubble features are micrometer diameter.

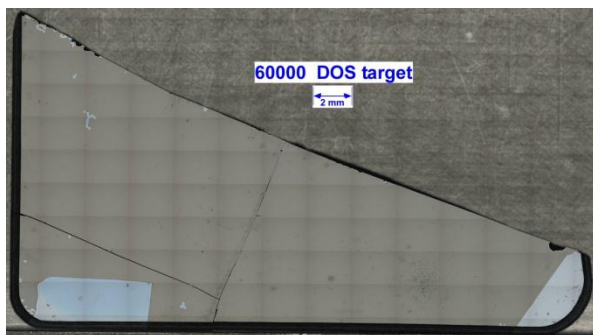
Fig. 6. Post-subdivision solar wind surface.

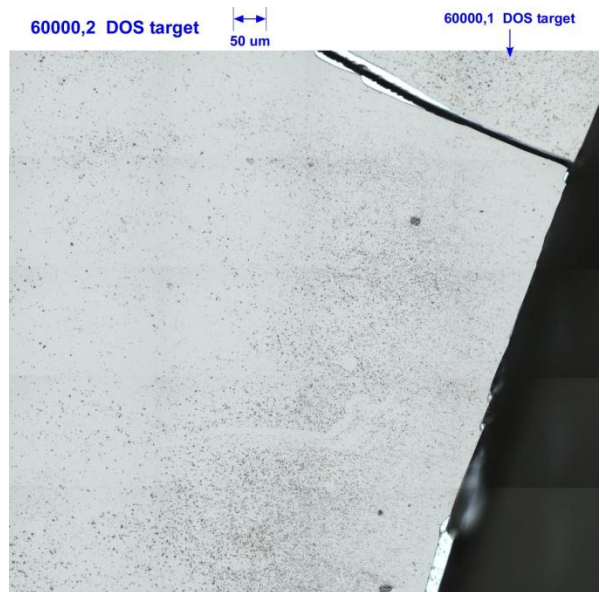
**Imaging after subdivision:** Fig. 6 shows solar wind surface after subdivision by laser scribe/cleaving. The subdivision process [4, 5] produces silicon/silicon oxide debris which gets onto the solar wind surface (Fig. 7) and needs to be removed. Further imaging of the subdivided surfaces is in progress.

Fig. 7. Subdivision process debris added near edges.
